THOMAS REAL ESTATE Inspections, Inc. Inspection Report

MOBILE/MODULAR HOME INSPECTION REPORT

Inspection Address: **12345 Main St. Grass Valley, Ca.**

PREPARED BY: Michael A. Thomas
Date of Inspection: 01/10/12

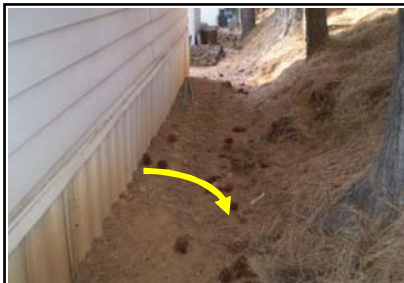
Positive grading & ditch noted along rear of house.

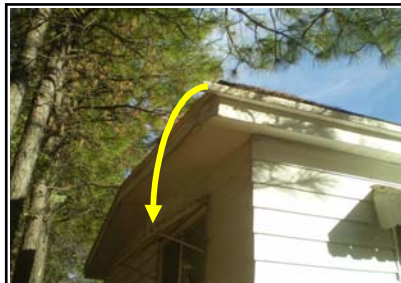
Positive grading noted around house. Swale/ ditch noted running across rear of property to help divert run-off past house. Open ended gutters noted are discharging roof run-off against house. Roof run-off is recommended to be diverted away from structure. Recommend installation of downspouts.

Open ended gutters are discharging roof run-off next to house.

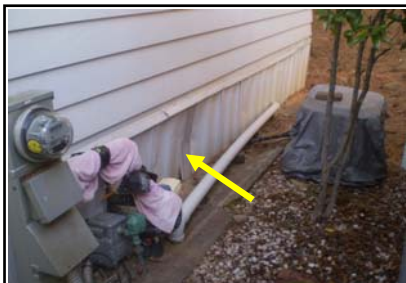
Skirting material bent, dented.

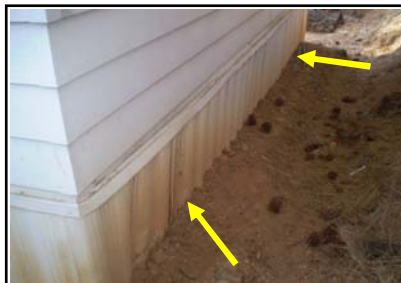
Wear noted to skirting material at soil contact.

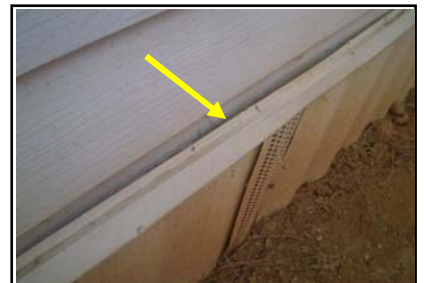
Loose skirting trim material noted.

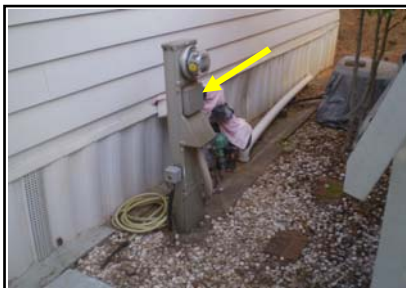
Main electrical disconnect is located at pedestal.

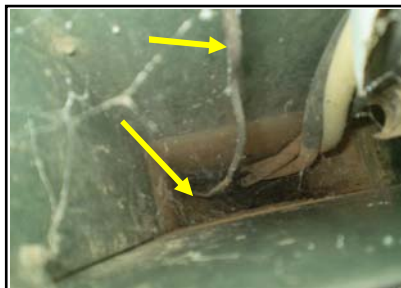
Electrical panel ground wire disappears into soil in bottom of panel.

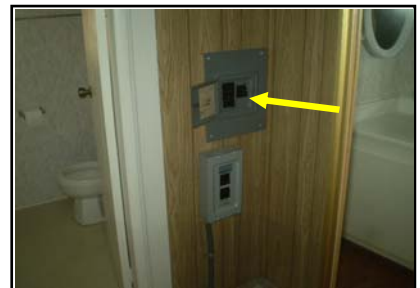
House breaker panels are not recommended to be in clothes closets.

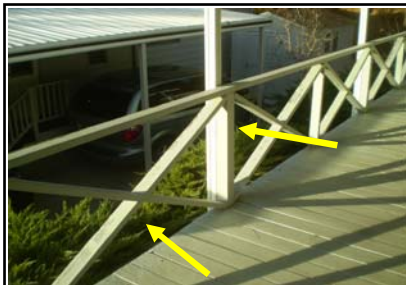
Open spaced railings are insufficient for small children.

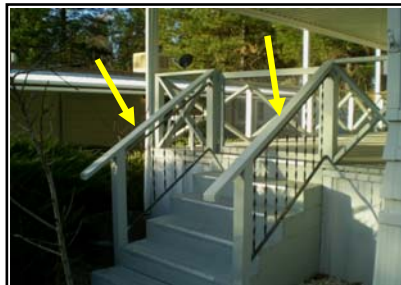
Graspable hand rails are not present at deck steps.

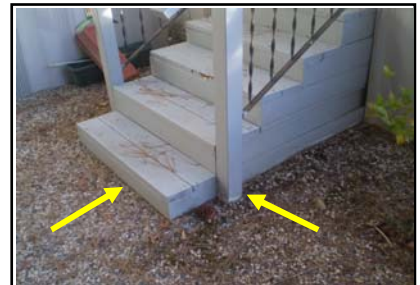
Earth to wood contact will accelerate wear to step & support post material.

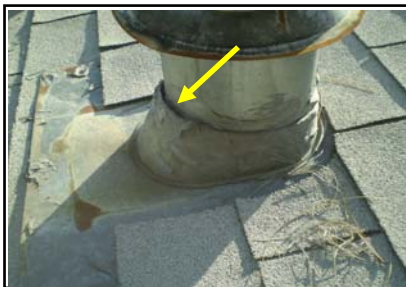
Gaps noted in vent pipe flashing sealant. Staining noted to water heater closet ceiling under flashing.

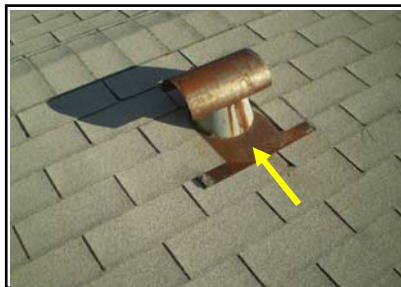
Rusting noted to vent pipe flashing.

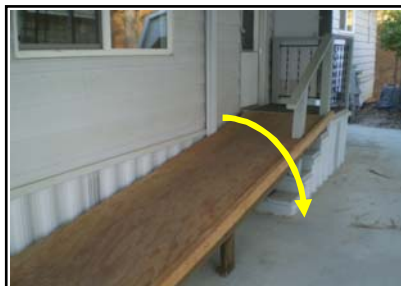
No railing & high edge noted off side of ramp.

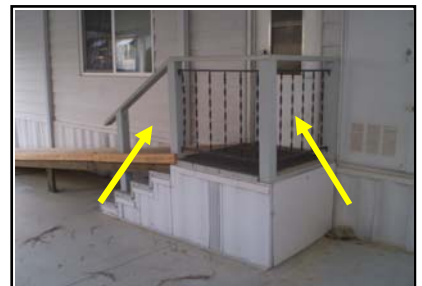
Porch railing openings are insufficient for small children.

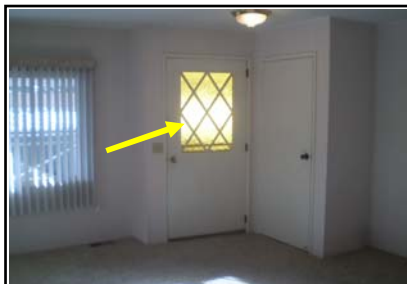
Front entry door glass is loose, rattles.

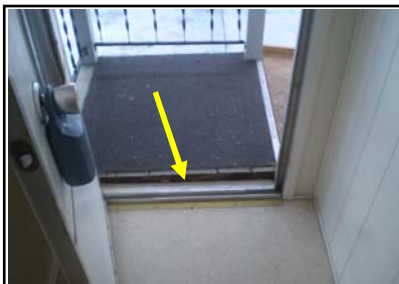
Uplifted edge noted out of right side entry door.

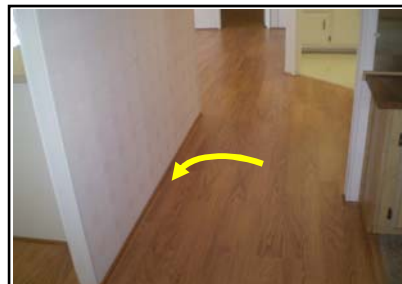
Unlevel flooring noted in center hallway.

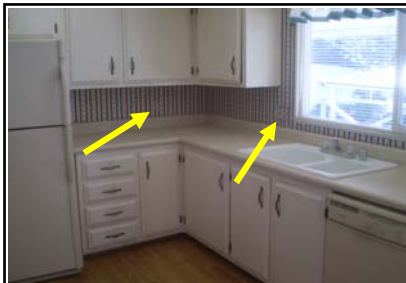
GFCI protection is recommended for sink counter outlets.

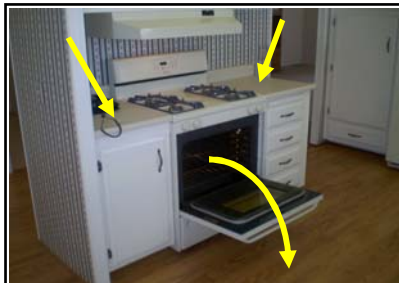
Stove anti-tip brackets are not installed. Counter tops are not secured to cabinet.

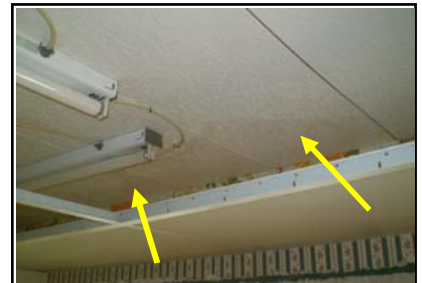
Staining noted to ceiling over sink area.

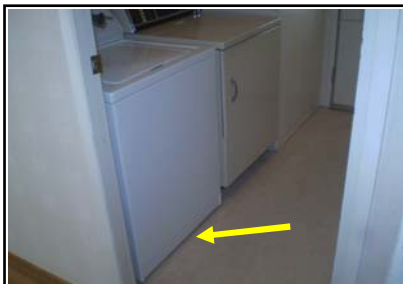
Drain pans are recommended under interior washers.

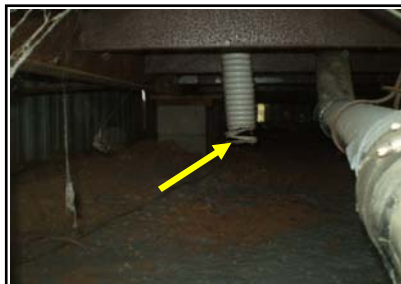
Dryer debris is discharging into crawl.

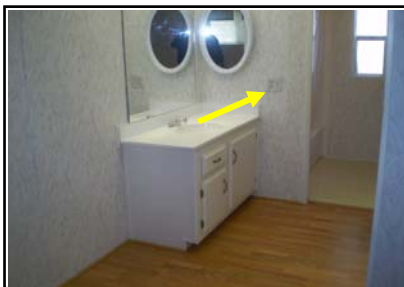
Master bathroom sink outlet is not GFCI protected.

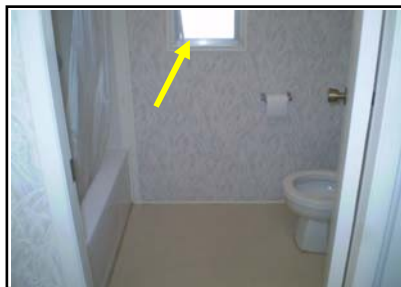
Bathroom window drops when opened.

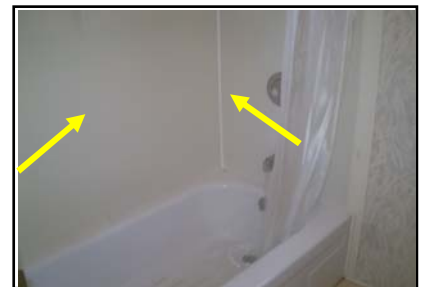
Individual single sheet panels noted in shower will leak if not maintained.

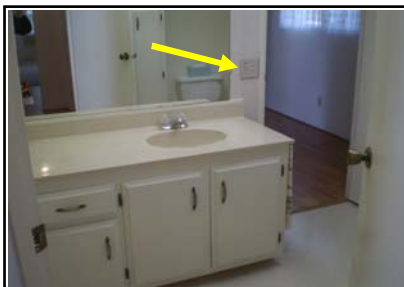
Bathroom # 2 sink outlet is not GFCI protected.

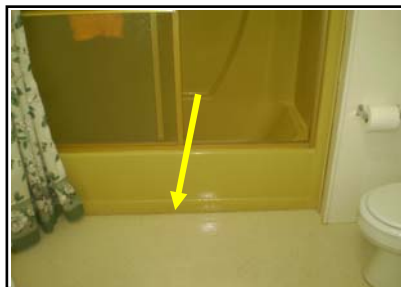
Recommend keeping tub seams/ edges caulked/ sealed.

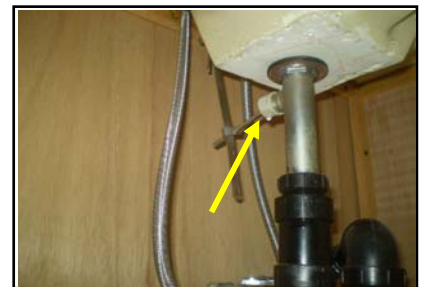
Leak noted at sink drain stopper assembly under sink.

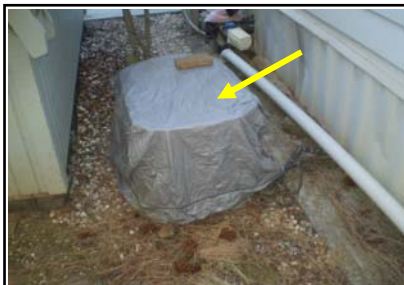
No electrical disconnect noted at AC condenser.

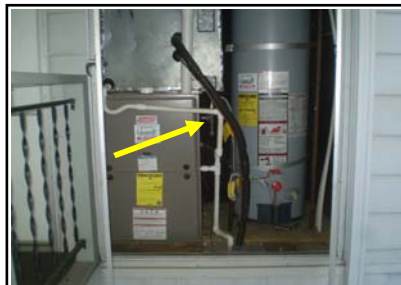
Exterior closet - furnace gas shut-off valve.

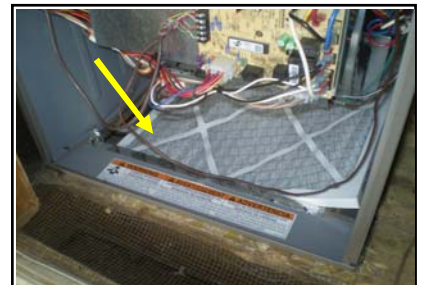
Return air filter in furnace has collapsed.

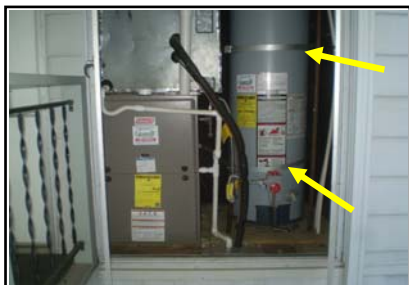
EQ strapping is not securing water heater from movement.

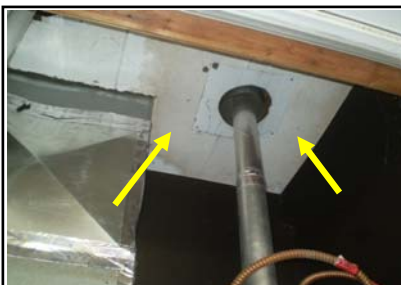
Staining noted to water heater closet ceiling.

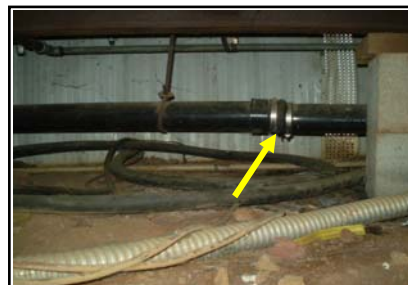
Draining was observed from sinks, tub/shower, toilets only. Leaking noted at flex connection on drain line in crawl under bathrooms.

Leaking noted at drain line flex connector under house.

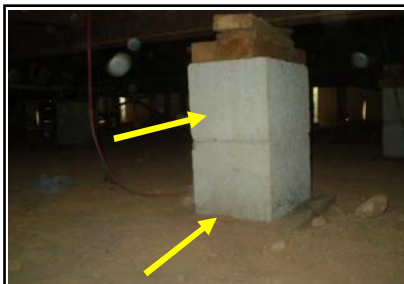
House support is concrete block on wood pads.

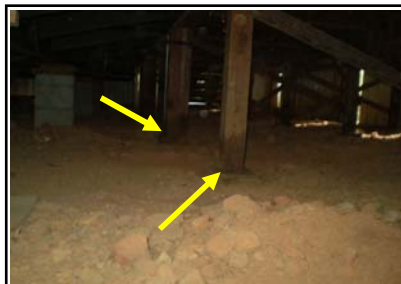
Earth to wood contact will accelerate wear to post material.
