**THOMAS REAL ESTATE
Inspections, Inc.
Inspection Report**

HOME INSPECTION REPORT

Inspection Address: **12345 Main St. Anytown, Ca.**

Date of Inspection: 1/4/2006

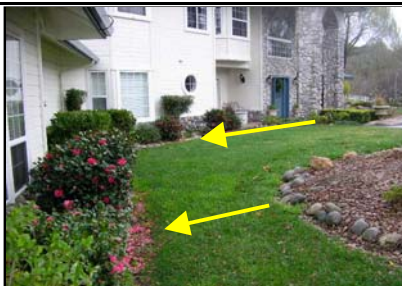
Negative grade noted towards front of house.

Front yard slopes towards front of house - unable to verify drainage system along front of house - recommended consider installation of french type drainage.

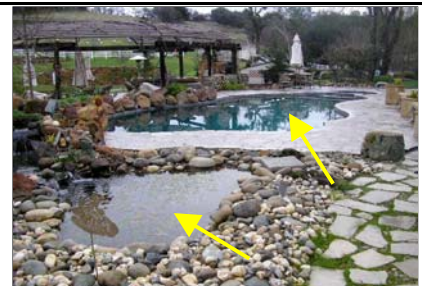
Child barriers are recommended around pools & water.

Fountain, pool, & pond noted - child barriers with self closing, self latching gates are recommended. Audible alarms are recommended on all exterior doors with direct pool access.

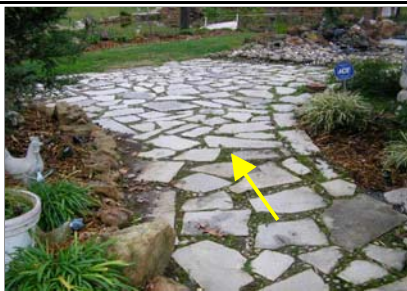
Watch for uneven walk surfaces.

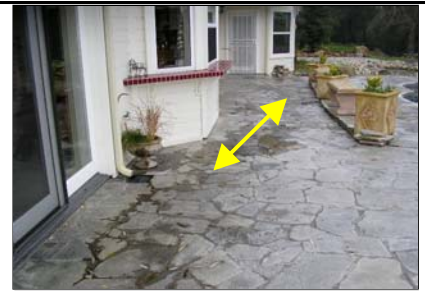
Settling cracks noted to stone & pool patio surfaces. Watch for uneven surface edges. Ponding noted on stone patio along rear of house.

Ponding water noted on stone patio behind house.

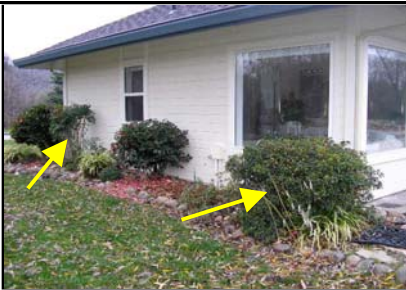
Recommend trimming vegetation away from siding.

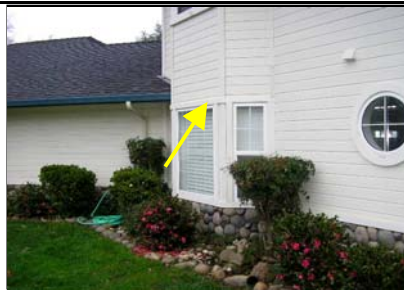
Caulking is recommended above window & siding trim.

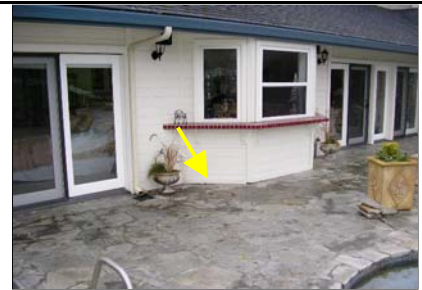
No clearances noted along rear siding material.

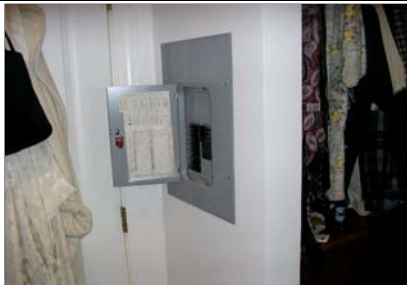
Sub panel located in master walk-in closet - if panel to remain, recommend not storing flammables in area around panel. 2 wires noted "Double Tapped" into a single wire 15 amp breaker.

Sub panel located in master closet.

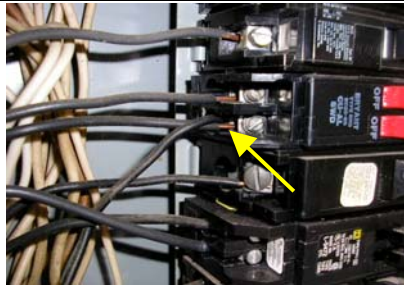
"Double Tap" noted at 15 amp breaker.

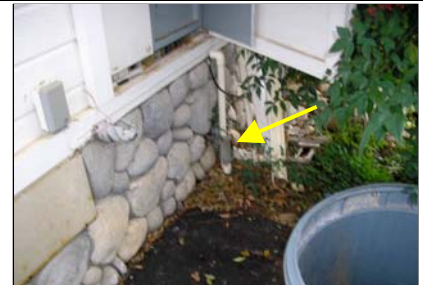
Exposed & uncovered wiring noted on exterior wall below main panel. Exterior left rear GFCI outlet did not trip when tested. Exposed wiring noted in garage attic next to access opening.

Exposed wiring in junction box below main panel.

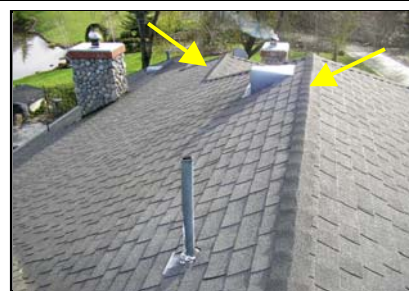
Routine wear noted to shingle surfaces. Moss build-up noted on rear/ north side roof faces. Exposed nail heads noted along right ridge cap shingles - recommend caulking nail heads.

Recommend caulking exposed nail heads along ridge cap.

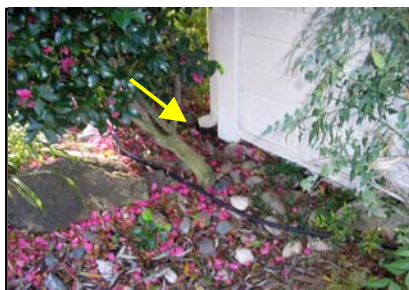
Recommend extensions on all downspouts.

Dripping noted at front gutter corners over front entry. Recommend extensions on downspouts to help divert water away from house foundation.

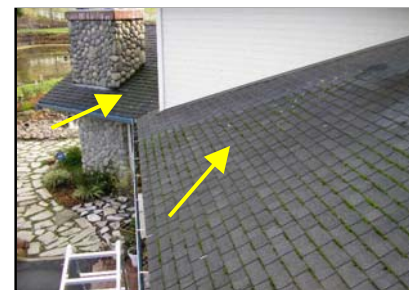
Moss build-up noted on rear/ north side roofing.

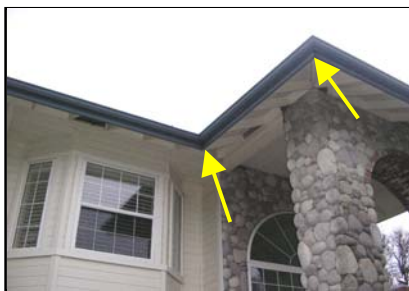
Dripping noted at front gutter corners.

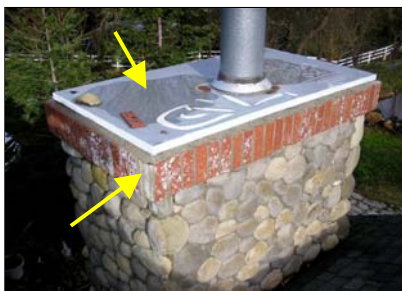
Cracking & gaps noted to stone veneer. Cracking & separation noted to brick trim - missing bricks noted. Ponding noted on flashing cap.

Left chimney - cracked veneer noted, missing bricks noted. Ponding water noted on cap.

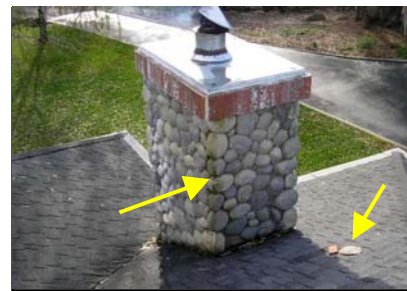
Cracking noted to stone veneer. Cracking noted to brick trim. Ponding noted on flashing cap.

Right chimney - cracked veneer noted, missing brick noted. Ponding water noted on cap.

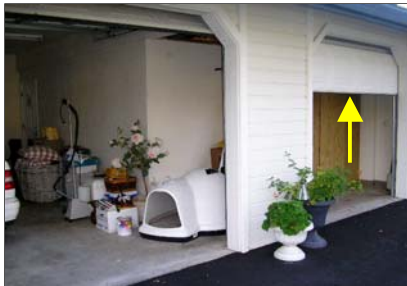
Right hand garage door opener hardware hits office framing during operation - door stops at half way point.

Right side garage converted. Garage door hangs up on office framing.

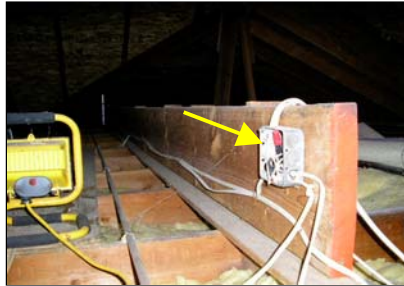
Right side of garage converted to office. Exposed wiring noted in garage attic next to access opening.

Exposed wiring noted in garage attic.

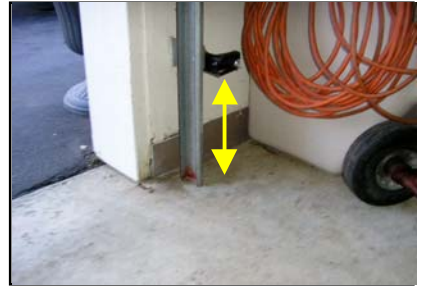
6 " max height recommended for electric door sensors. Garage door opener did not auto reverse when door was blocked - electric eye sensor noted & working.

6 " max recommended for door sensors.

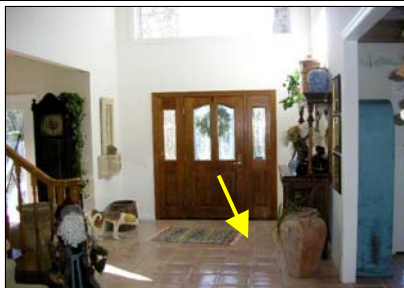
Cracking notes is entry hull floor tile.

Front entry - cracking noted to floor tile.

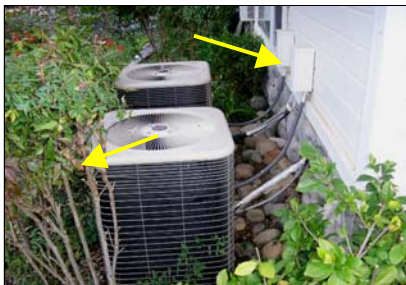
AC condensers & disconnects. Vegetation contacting units.

Tears noted to duct vapor covering - loose duct insulation noted. Recommend trimming vegetation away from AC condenser units.

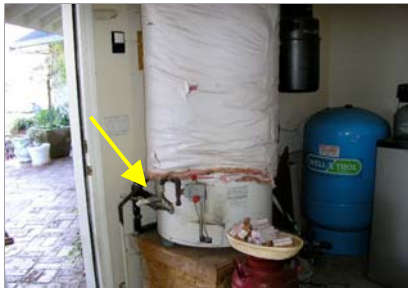
Water heater gas shut-off valve. No EQ strapping noted.

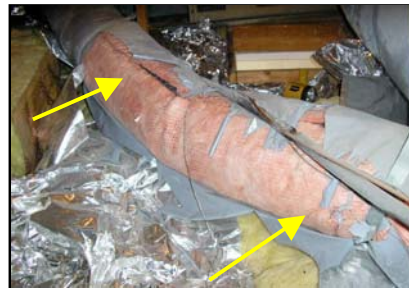
Deterioration noted to duct vapor covering
