THOMAS REAL ESTATE Inspections, Inc. Inspection Report

HOME INSPECTION REPORT

Inspection Address: **12345 Main St. Anytown, Ca.**

Date of Inspection: **10/26/2011**

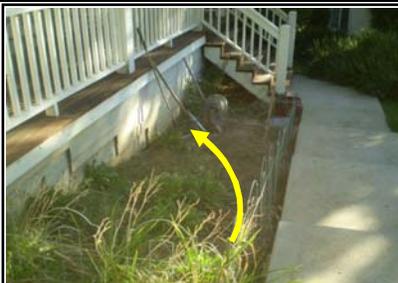
Negative grading noted along front of house. Downspouts are noted discharging roof run-off against house foundation. Extensions/ drain lines are recommended on all downspouts to help divert water away from house. Cracking noted to rear yard concrete & stone wall material.

Negative grading noted along front of house.

Recommend improvement of drainage to direct water away from foundation

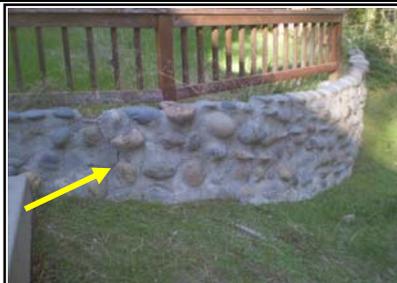
Rear yard wall material cracked.

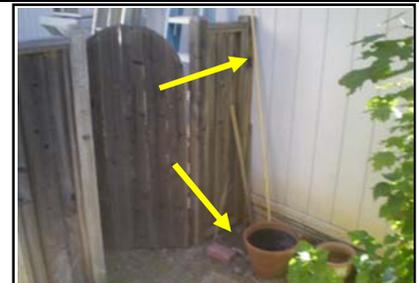
Metal wire fencing noted in rear yard. Wood fencing buried in soil & contacting house siding may provide an entry point for pests. A gap &/or flashing is recommended between wood fencing & house siding.

Wood fencing contacting soil & house siding.

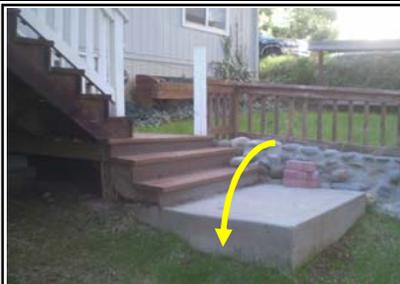
High edges noted off rear deck steps landing.

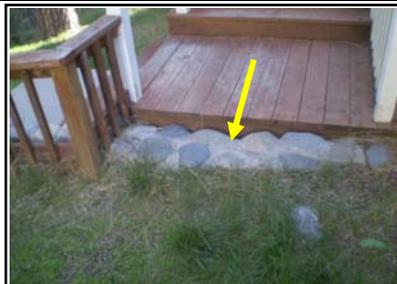
Uneven surface material noted behind house.

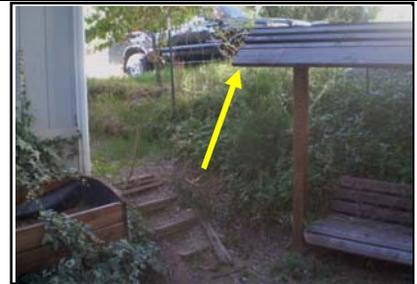
Low head clearance noted under rear yard seat cover material.

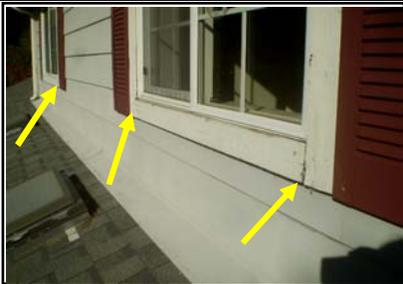
Wear noted to upper window trim material.

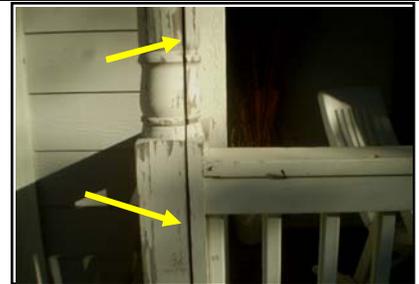
Cracking & splitting noted to front deck cover support material.

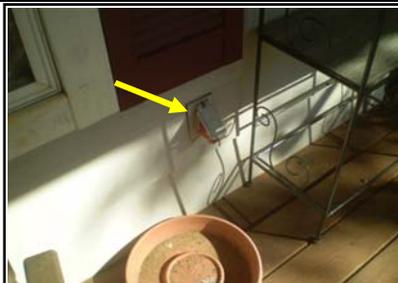
Front porch GFCI outlet is not functioning. GFCI does not trip. Exterior outlets are not GFCI protected. Recommend correction to GFCI reset outlet & retest of exterior outlets for GFCI protection. Rain tight covers are recommended on all exterior outlets in wet locations.

Front porch GFCI outlet is not functioning.

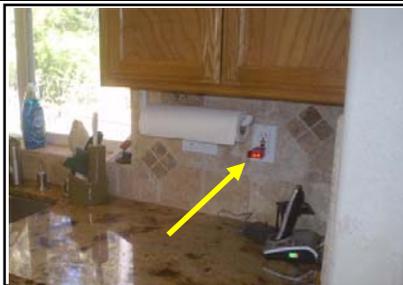
Exterior, kitchen, bathroom 2 GFCI outlets do not function.

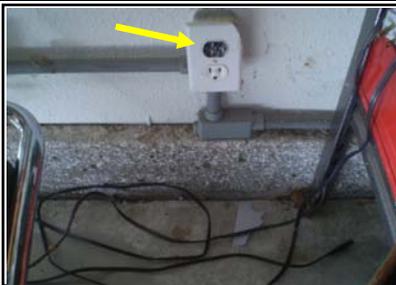
No power at garage left wall outlet - black plug.

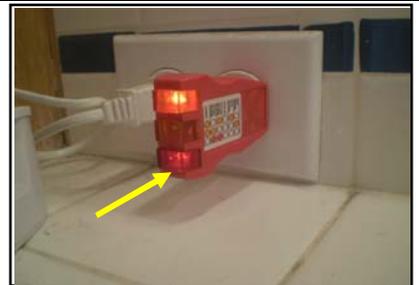
Reversed wiring noted at master bathroom left sink outlet.

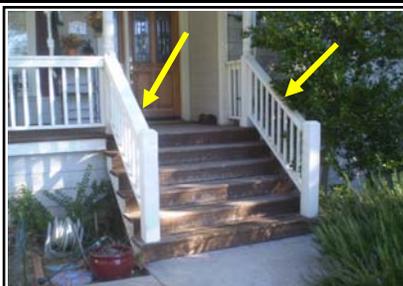
Graspable hand rails are not installed at front & rear steps.

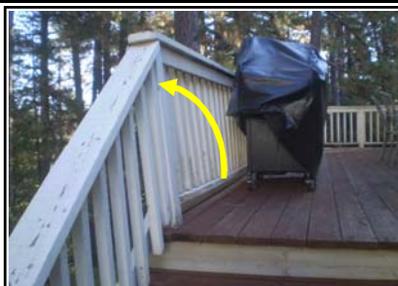
Rear deck railing is loose & leaning. Baluster material is worn.

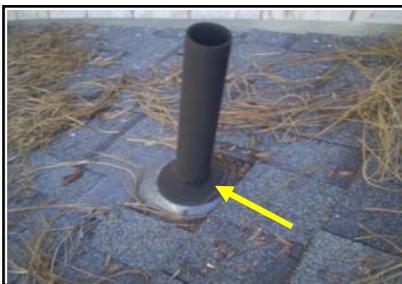
Cracked & worn weather collars noted on plumbing vent pipe entries through roofing may allow water entry into attic. Recommend replacement of cracked/ worn weather collars on plumbing vent pipes. Recommend keeping vegetation trimmed off & away from roofing surfaces. Vegetation contact to roofing may accelerate wear, lift material, & allow an entry point for pests. Recommend clearing debris from roof surfaces. Debris build-up may collect & back up water under shingles & flashing. Un-caulked nails noted at plumbing & vent flashing may allow water entry under flashing into roof sheathing. Caulking is recommended at all nail penetrations through roofing. Wear noted to upper left & right side gable wall siding & trim material.

Recommend replacing cracked vent pipe weather collars.

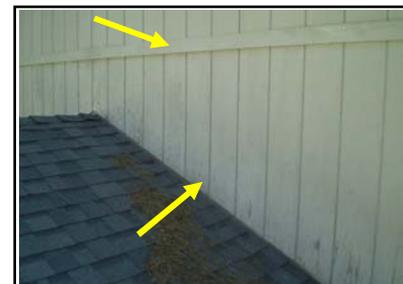
Wear noted to upper siding finishes & material.

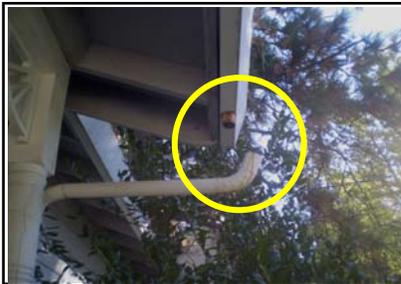
Downspout over front entry disconnected.

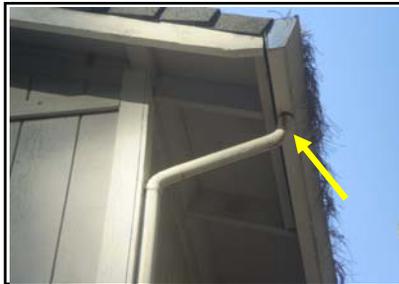
Leaking noted at right rear downspout.

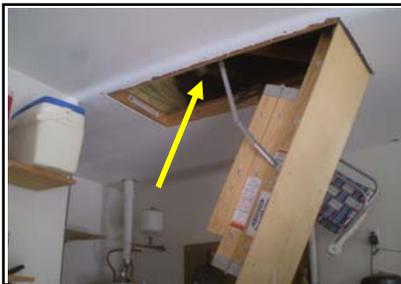
Attic access opening reduces garage to house fire protection.

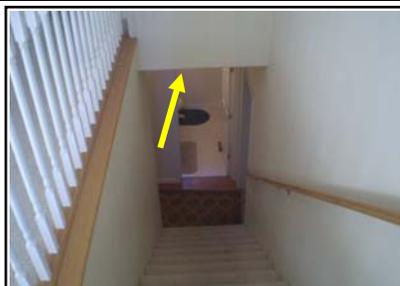
Low head clearance noted at bottom of stairs.

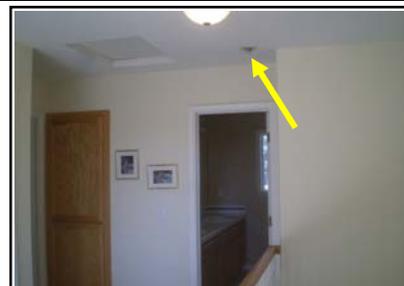
Upper hall smoke alarm has been removed.

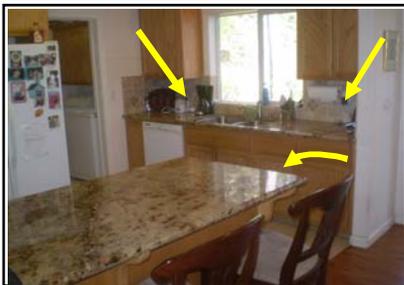
Kitchen outlets are not GFCI protected.

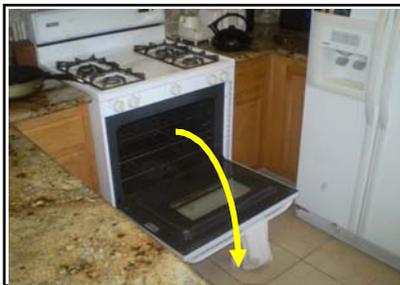
Stove/ oven anti-tip brackets are not installed.

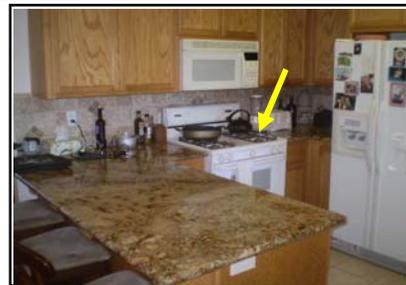
Stove front right burner did not ignite.

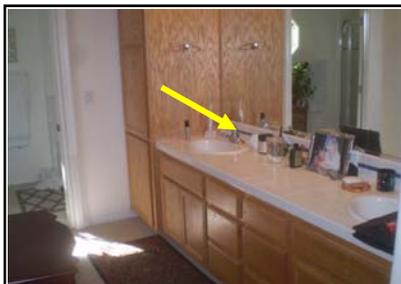
Carpet in front of sink cabinet stained, worn. Reversed wiring noted at sink counter left outlet - recommend correction.

Master bathroom - wiring at left sink outlet reversed.

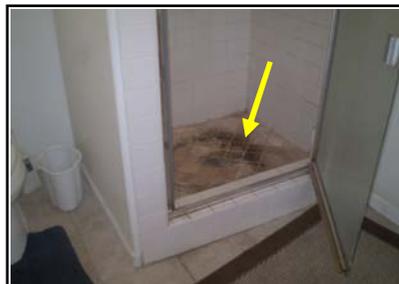
Staining noted to shower surface. Worn grout/caulk noted.

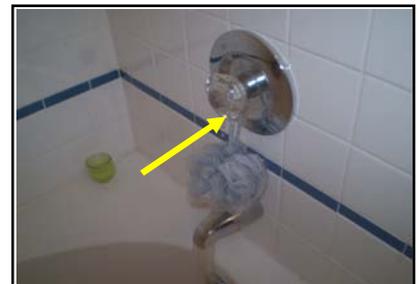
Leaking noted at tub faucet handle.

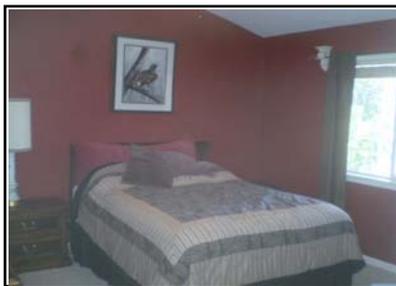
Bedroom # 3 - smoke alarm has been removed.

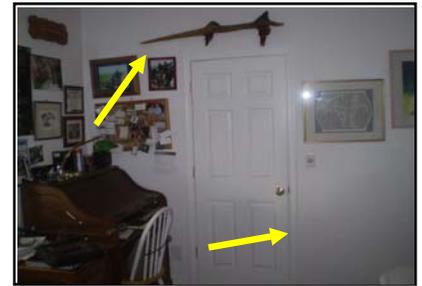
Room entry door does not close, hits door frame. Wall material around door is cracked & has settled.

Office - wall material cracked & separated. Door does not close.

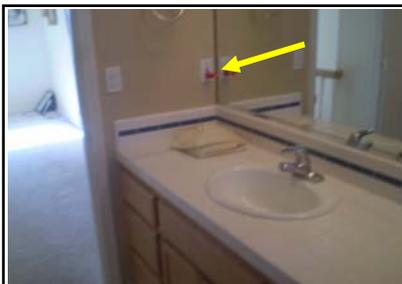
Bathroom # 2 - GFCI outlet not functioning, does not trip.

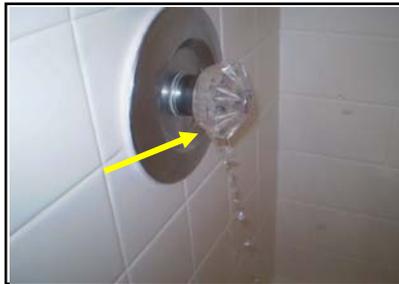
Leaking noted at tub faucet handle.

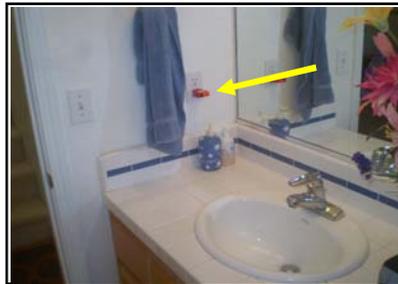
Sink outlet is not GFCI protected.

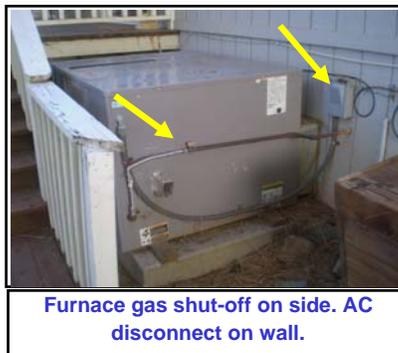
No drip leg/ sediment trap noted on furnace gas supply connector as recommended by the manufacturer. 45 amp fuses noted at AC condenser disconnect are within manufacturers recommendations stated on unit.

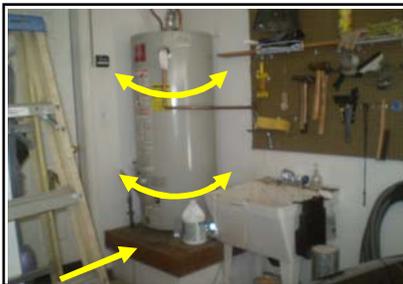
Water heater EQ strapping not installed. Drain pan not installed.

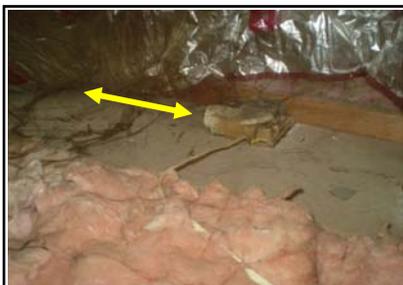
Bathroom exhaust fan does not terminate to building exterior.

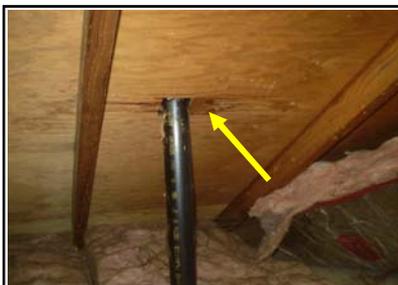
Staining noted at plumbing vent pipe entries through roofing.

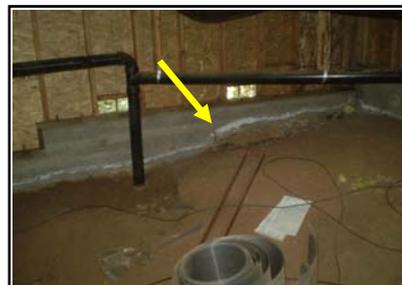
Efflorescence noted along front & side foundation walls. Negative grading noted along front of house. No evidence of water entry noted into crawl during inspection. Access under front entry deck/porch is through front of crawl under center of house. Insufficient ventilation noted for area under front deck/porch.

Efflorescence noted along front & side foundation walls.
